2020 ANNUAL REPORT

TENNESSEE STATE BUILDING COMMISSION

Prepared by Tony Guzzi, Vice-President, Preservation and Site Operations
Andrew Jackson's Hermitage | Andrew Jackson Foundation
4580 Rachel's Lane, Hermitage, TN 37076
615.889.2941 ext. 225 | Fax 615.889.9289
tguzzi@thehermitage.com

This Annual Report to the Tennessee State Building Commission (SBC) describes preservation and significant maintenance and management work completed on historic and cultural resources at Andrew Jackson's Hermitage by the Andrew Jackson Foundation (AJF) in calendar year 2020 and proposed work for calendar year 2021. This annual report submission is required under Tennessee Code Annotated section 4.13.104. The following is a brief description of proposed property acquisition, construction, demolition, alteration, restoration, or preservation works in progress. Projects involving routine maintenance and minor repairs are not included. Projects are listed in order of priority.

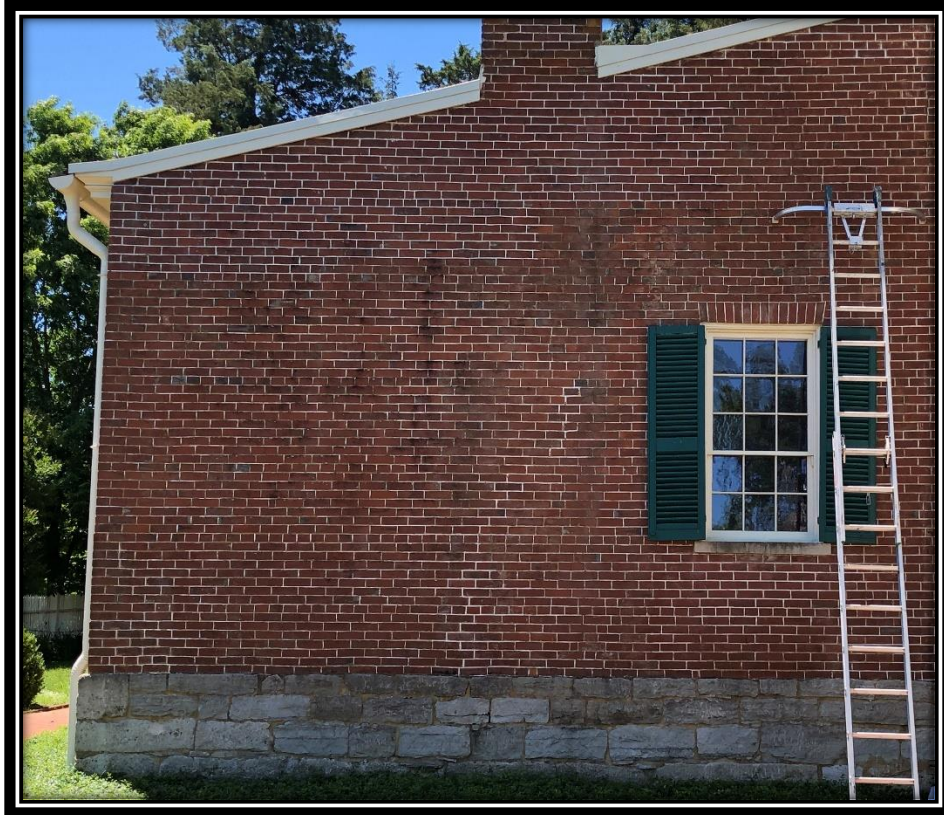
*Re-penciling brick mortar joints on north wall of the Hermitage east wing.
Note completed sections on upper half of wall, April 2020.*

- In 2019, contractors repainted the Hermitage mansion roof, north portico and columns, all wood trim, gutters, and downspouts. In June 2020, the AJF completed the Hermitage Mansion Exterior Re-painting Project. Contractors re-painted the brick walls on the south façade and completed re-penciling the brick joints on the north wall of the east wing. This project was the first major re-painting of the mansion exterior since the 2009-2010 Hermitage Mansion Restoration Project, which was funded by the State of Tennessee. The sand painted surfaces of the Hermitage mansion, the shutters, and sheet metal covered parapet wall were the only surfaces of the Hermitage mansion exterior not repainted in 2019 and 2020. These surfaces were cleaned, but the paint was still sound. The AJF hopes that the sand painted surfaces will last another 3-5 years before repainting is required. Sand painting is more expensive than traditional painting and it requires stripping paint after two coats due to the weight of the paint. Contractors also repainted the Hermitage mansion smokehouse roof and trim to match the Hermitage as part of this 2019-2020 project. This work was funded by a grant from the Metropolitan Government of Nashville and Davidson County and the Community Foundation of Middle Tennessee.

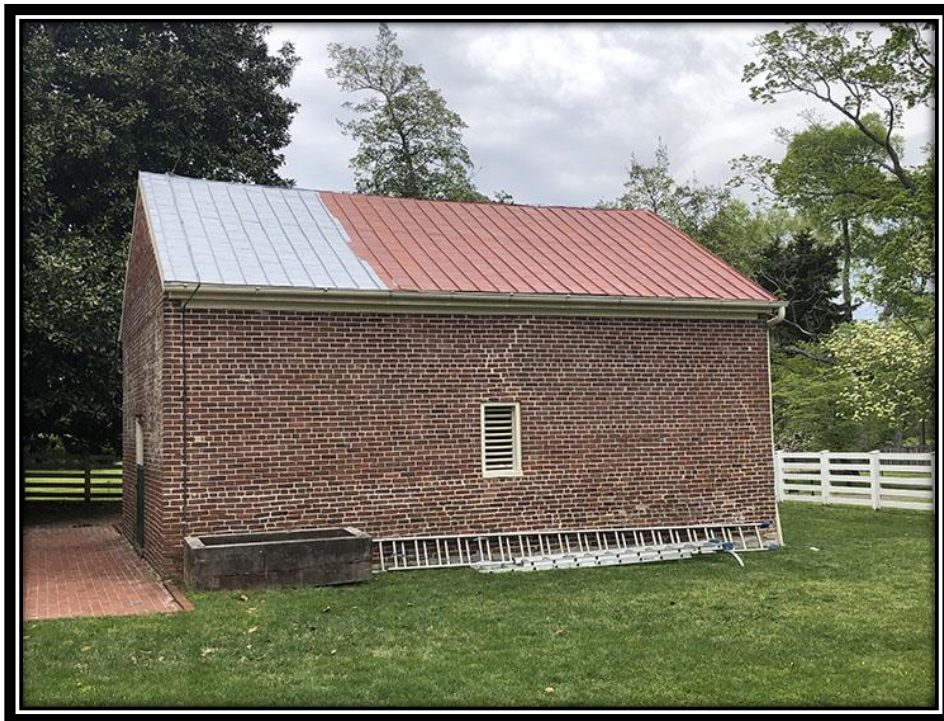
Hermitage smokehouse roof during painting, April 2020.

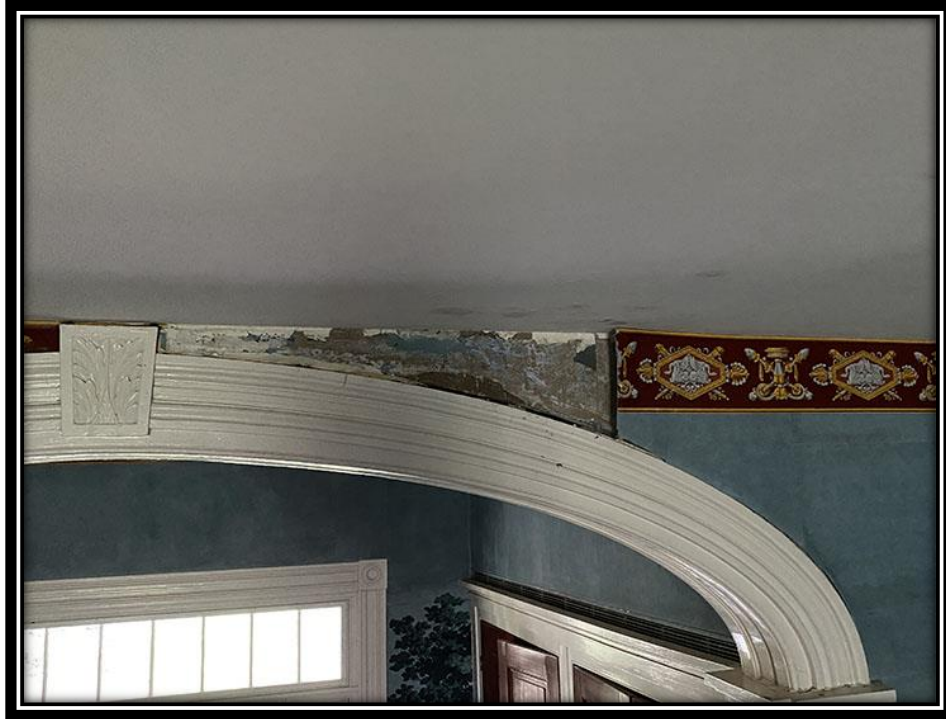
Ceiling, plaster, and wallpaper damage caused by a clogged condensate drainage line, August 2020.

- Water Leak Repair. In August 2020, a clogged air conditioning condensate drain caused a leak from the attic down into the upstairs main hall. Repair of plaster wall and ceiling, ceiling repainting, and wallpaper conservation required due to the water damage. Estimated cost \$25,000.

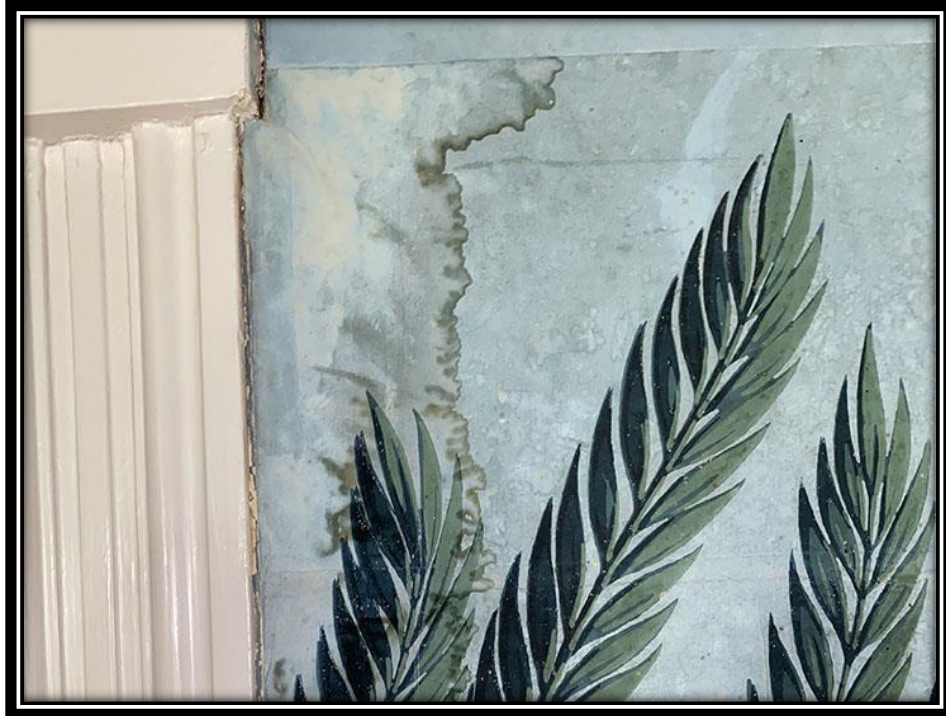
Damage to c.1818 wallpaper in Hermitage mansion upstairs hall from clogged condensate drain, August 2020.

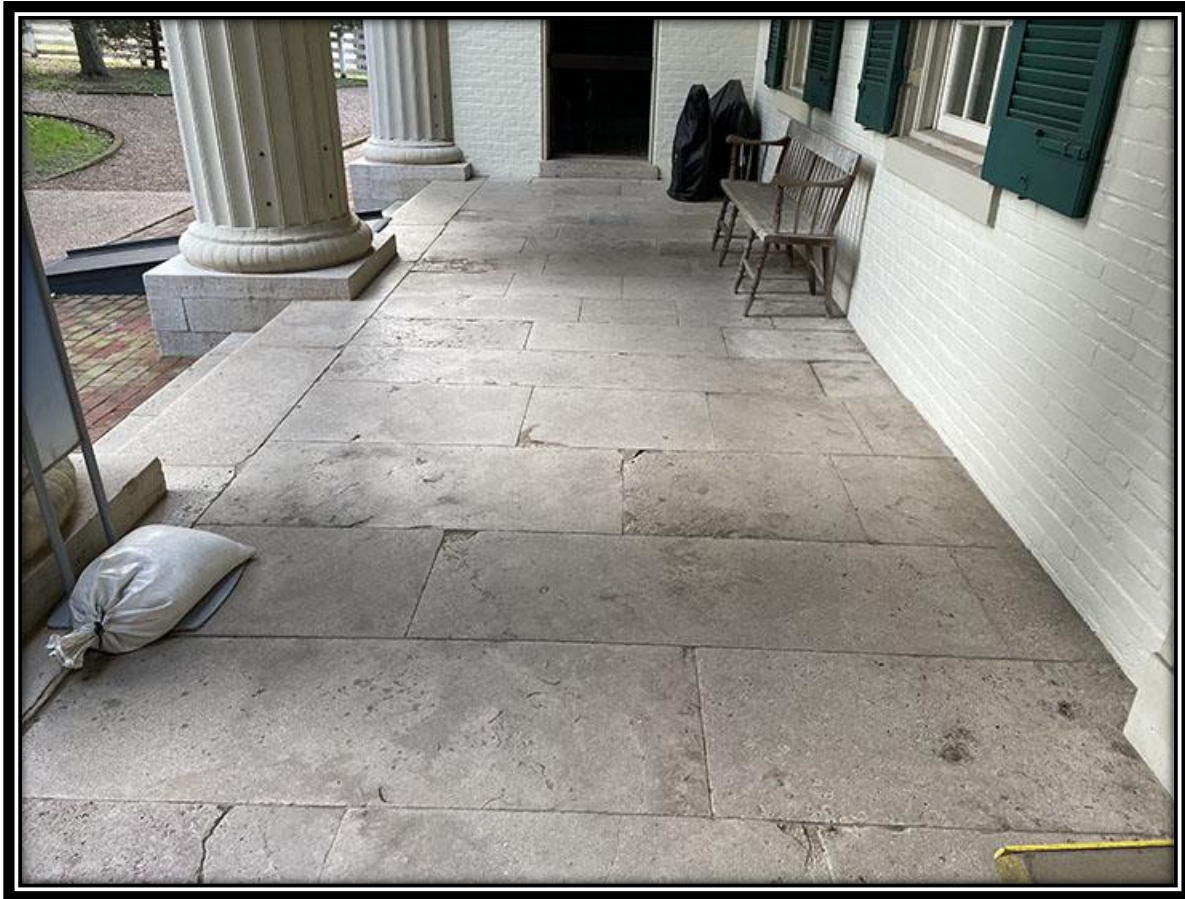
View of Hermitage mansion south porch, December 2020.

- Hermitage Stone Front Porch, Column Bases, and Steps. The Hermitage mansion front porch is comprised of slabs of Tennessee limestone. The elastomeric sealant joints between these slabs have failed allowing water into the soil below. Some soil subsidence has begun, and a few slabs have sunk or moved. The elastomeric sealants used in the front column base joints have also failed. Mortar joints in the Hermitage mansion's limestone slab steps have failed and two stones are showing subsidence. All the mortar or sealants that have failed must be replaced with the best possible material and any stones that have subsided need to be realigned. No cost estimate available.

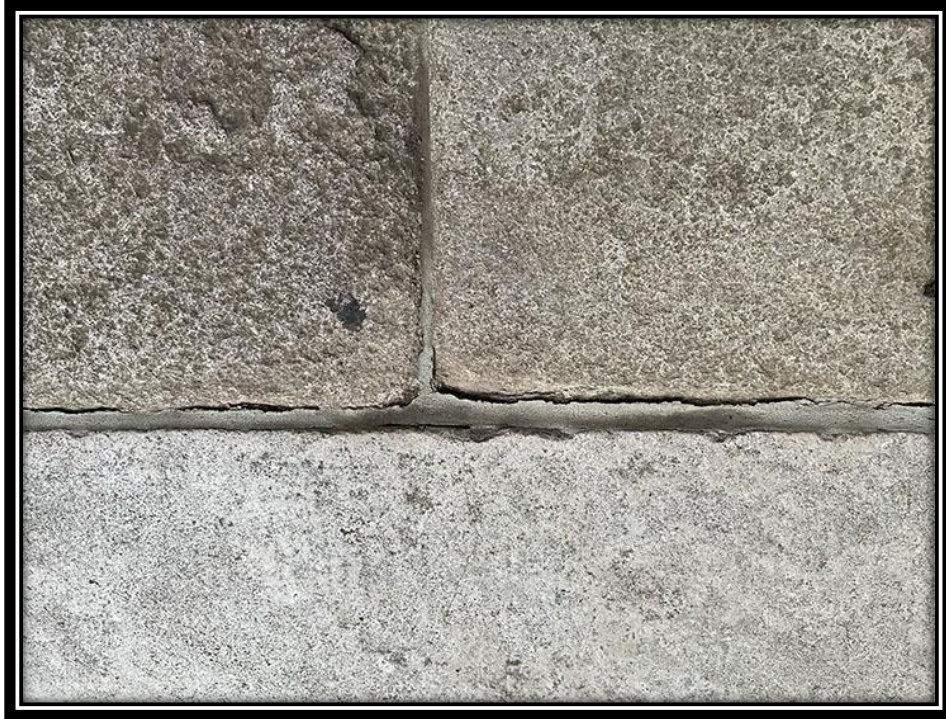
Typical sealant failure in porch floor stone joints, December 2020.

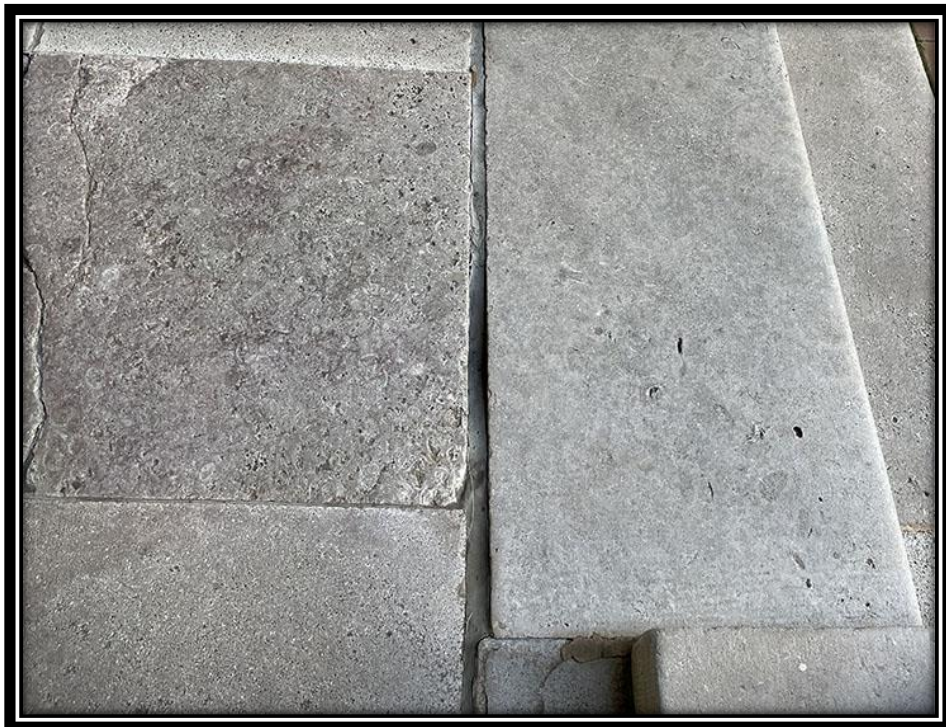
Failed joint, stone movement, and stone subsidence, December 2020.

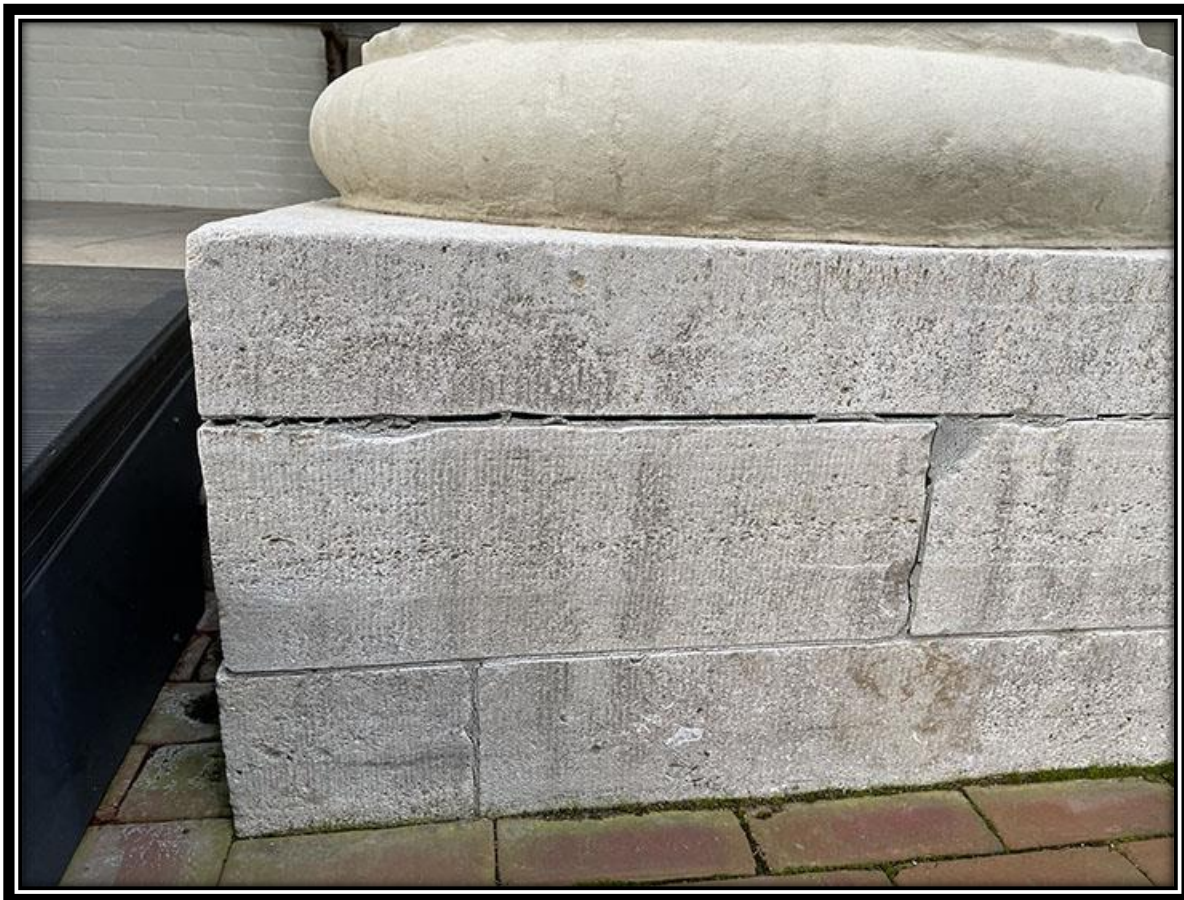
Failed sealant joints in column bases, south front, December 2020.

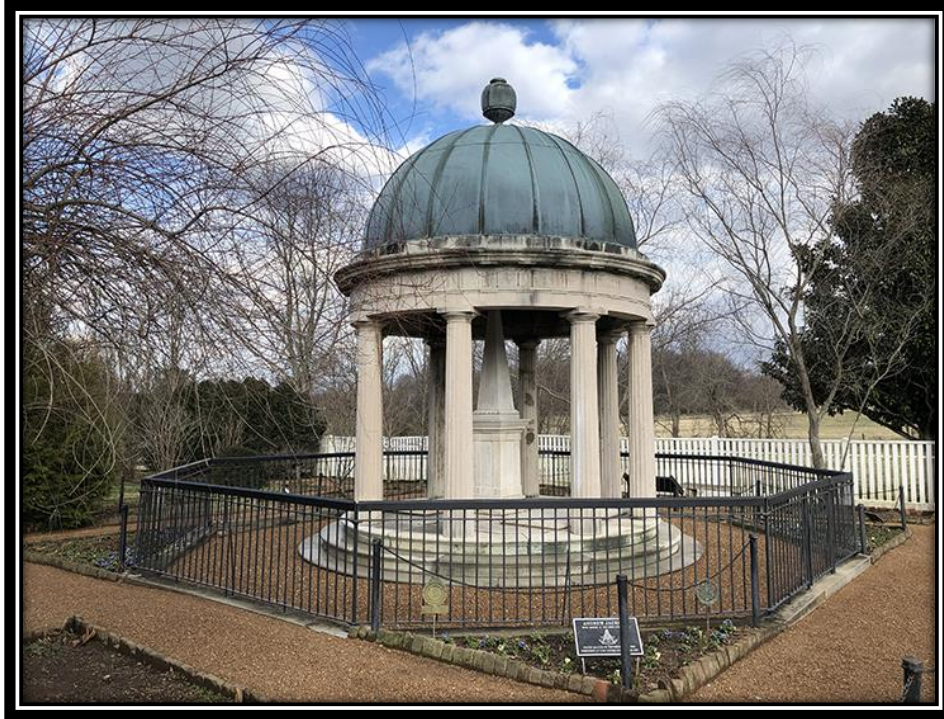
Overall shot of Tomb cleanliness, January 2020. Note much brighter white of obelisk in center of tomb that was cleaned after April 2018 vandalism

In April 2018, politically motivated vandals spray painted obscenities and political symbols on the Tomb of Rachel and Andrew Jackson. The Andrew Jackson Foundation hired Conservation of Sculpture and Objects Studio (CSOS) from Chicago, Illinois to remove the graffiti from the Tomb through laser ablation. Post removal, CSOS recommended that the Foundation clean the entire surface of the Tomb to correct the visual disparity between areas cleaned due to the vandalism and areas not cleaned. CSOS recommended removing the existing copper salt stains on the Tomb's porous stone surfaces and then sealing the copper dome surface to prevent future staining.

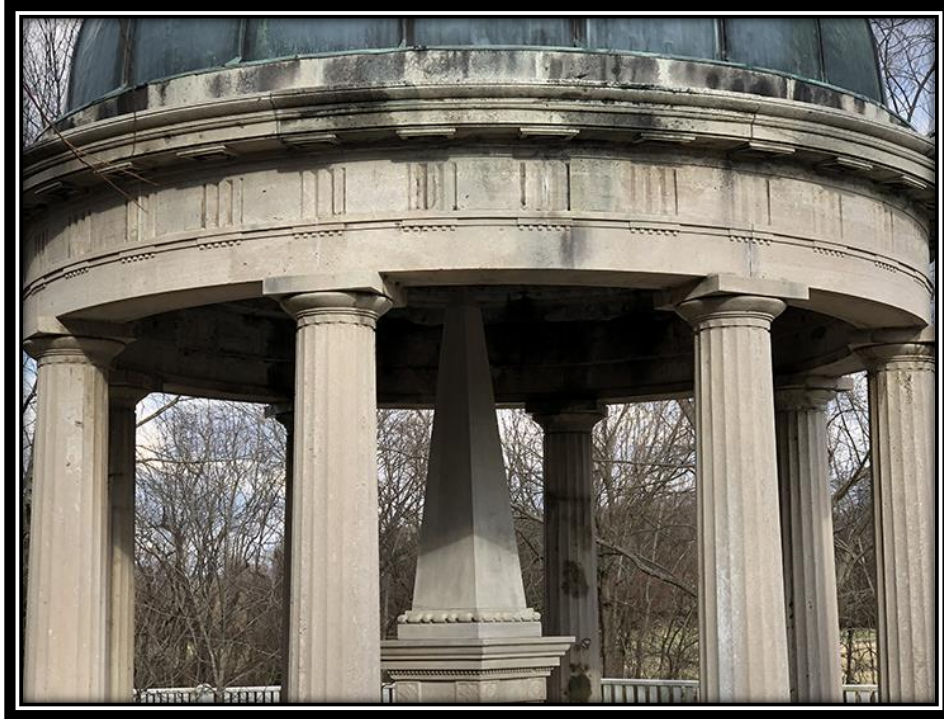
Close-up photograph of tomb showing black and green discoloration caused by copper salts run-off, February 2020.

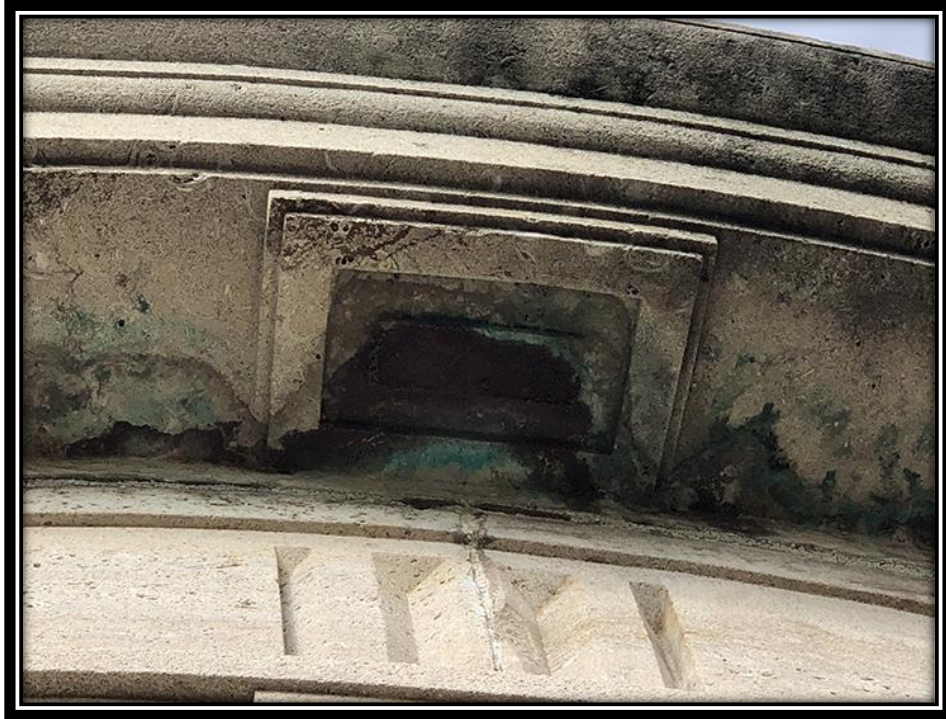
Close-up of Tomb cornice showing copper salt staining, February 2020.

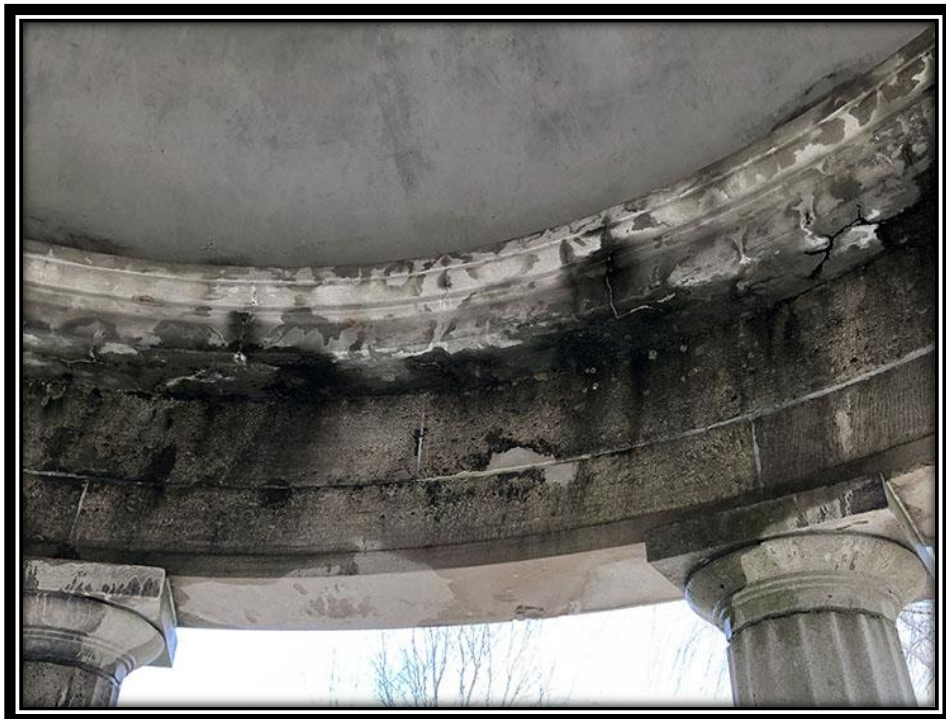
Staining caused by copper salt and rainwater penetrating the stone from failed sealant joints atop cornice circumference and parapet head joints, February 2020.

In addition, the AJF's preservation architect, Joseph K. Oppermann, identified the Tomb's cornice and parapet sealant joints as major areas of concern. These failed sealant joints are actively allowing water to penetrate the stone during rains. Oppermann advised that these joints be removed and replaced with more flexible and durable sealants or with packed lead wool. The cost for this project is \$130,000. The AJF needed two years to raise funds for this work. The AJF's funding is from Chubb Insurance, a grant from the Tennessee Historical Commission, and from private donors.

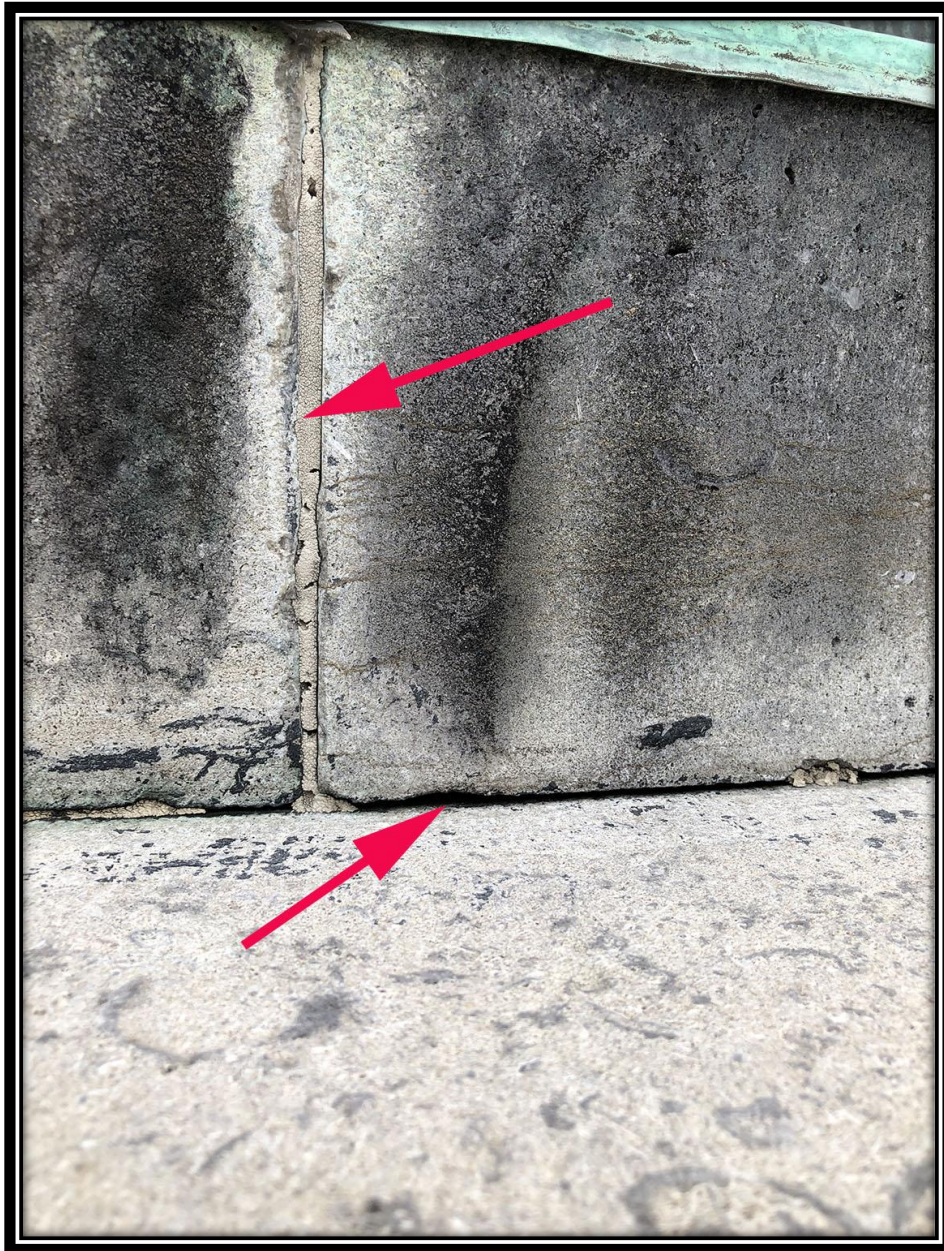
Failed head sealant joints in between parapet stones. Failed joint between parapet stones and top of cornices stones that runs the full circumference of the Tomb, February 2020.

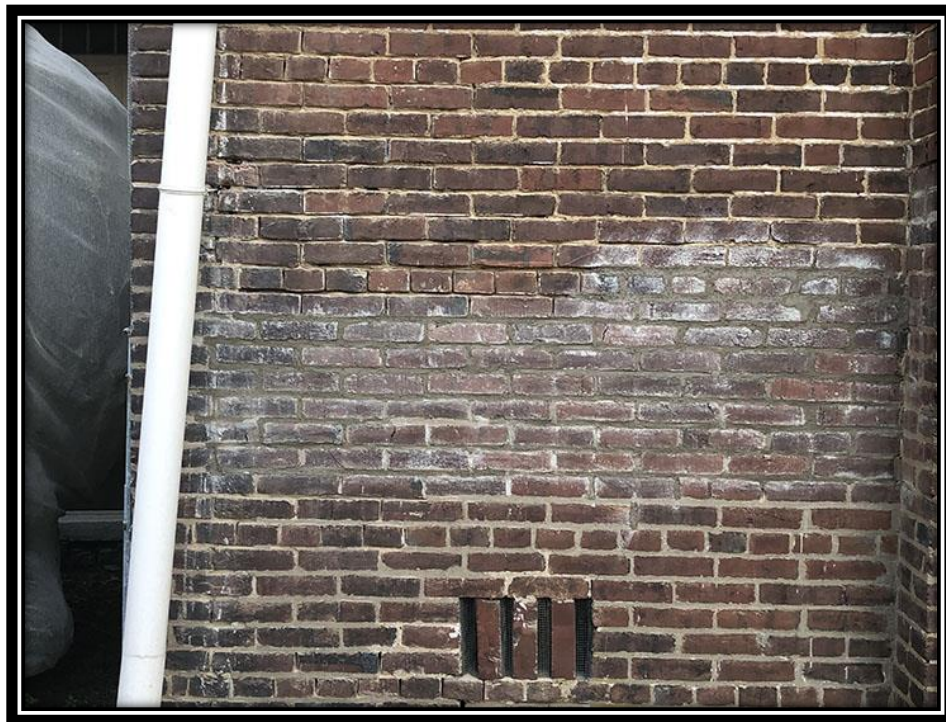
*Open mortar joints re-pointed, Tulip Grove east wall south wing,
November 2020.*

these funds, the AJF was able to contract with WASCO to repoint all open joints and re-point the most deteriorated of the remaining mortar joints in the late fall of 2020. Total cost \$7,500.

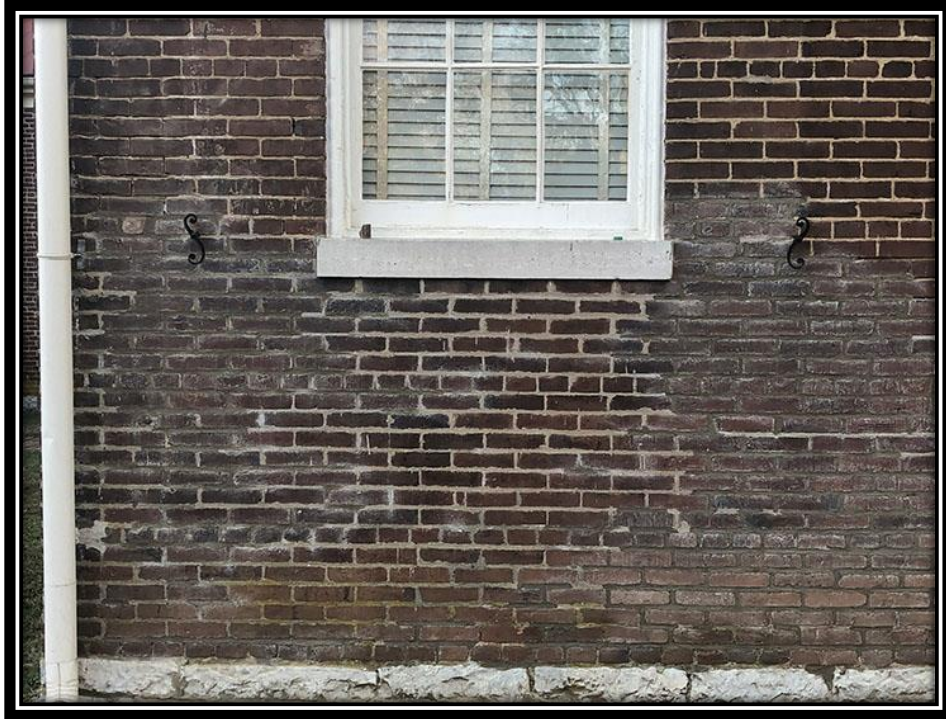
*Deteriorated mortar joints re-pointed, Tulip Grove north wall north wing,
November 2020.*

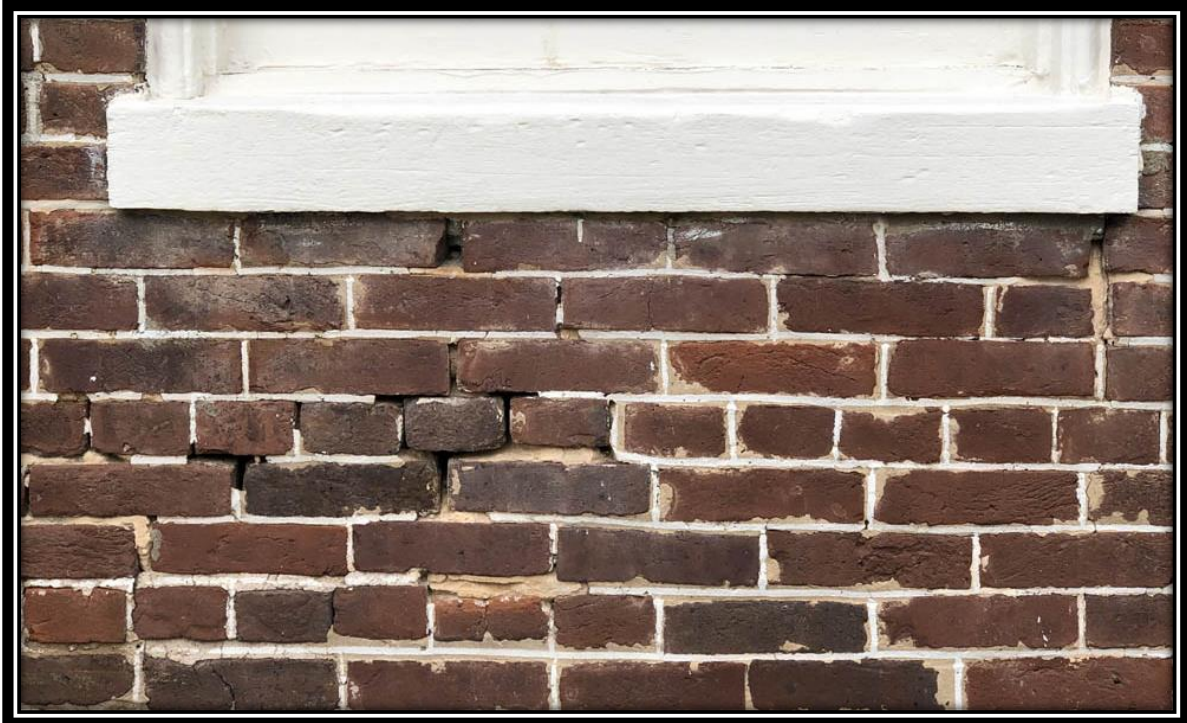
Progress of mortar joint decay on west elevation, December 2018.

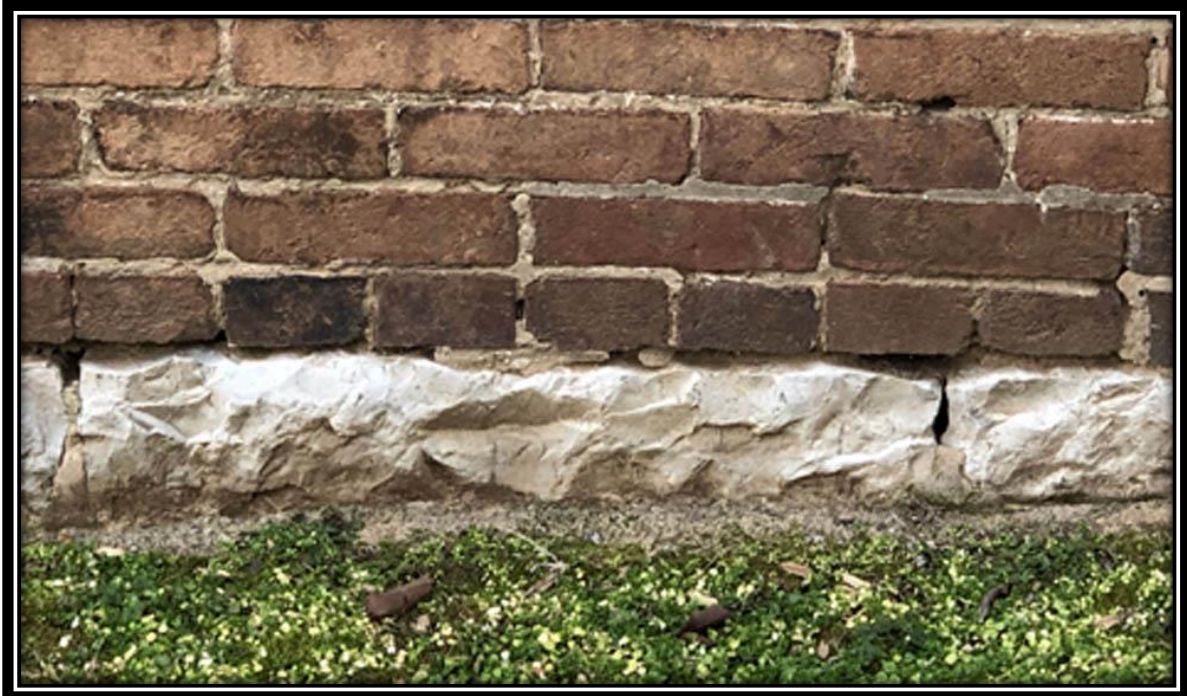
Foundation mortar joint deterioration at Tulip Grove kitchen, December 2018.

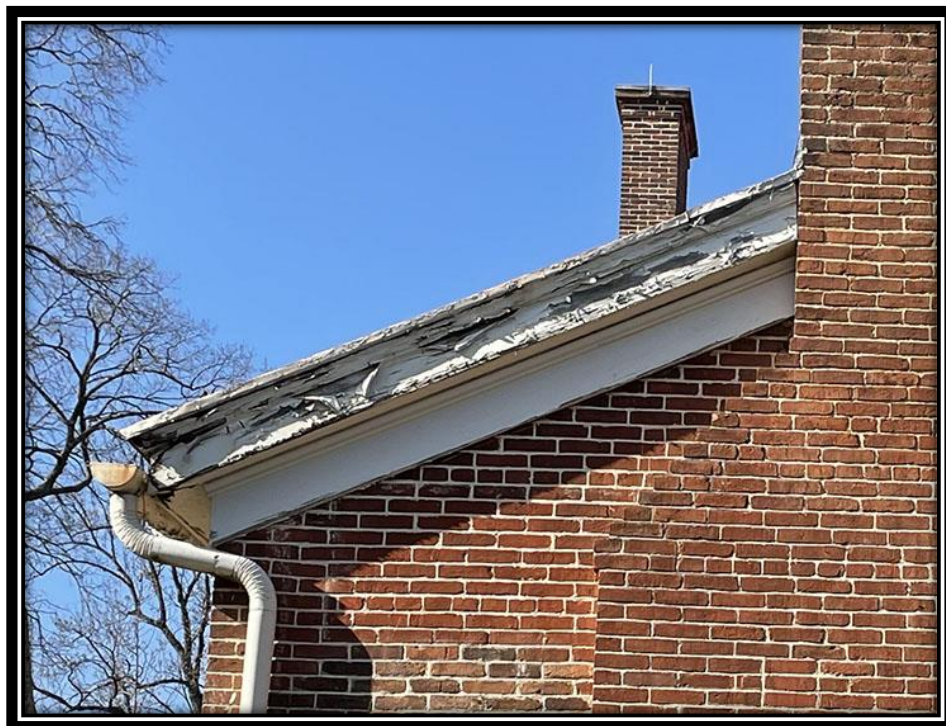
Rotted trim board and deteriorated gutter on south wing, east elevation, December 2020.

Replacement of failed gutters at Tulip Grove was the second emergent repair identified in last year's Annual Report. The AJF included replacing these gutters in its FY 2021 budget, but the financial distress wrought by COVID-19 forced the cancellation of that project. The AJF is seeking funding to replace the gutters, cost estimate \$10,000.

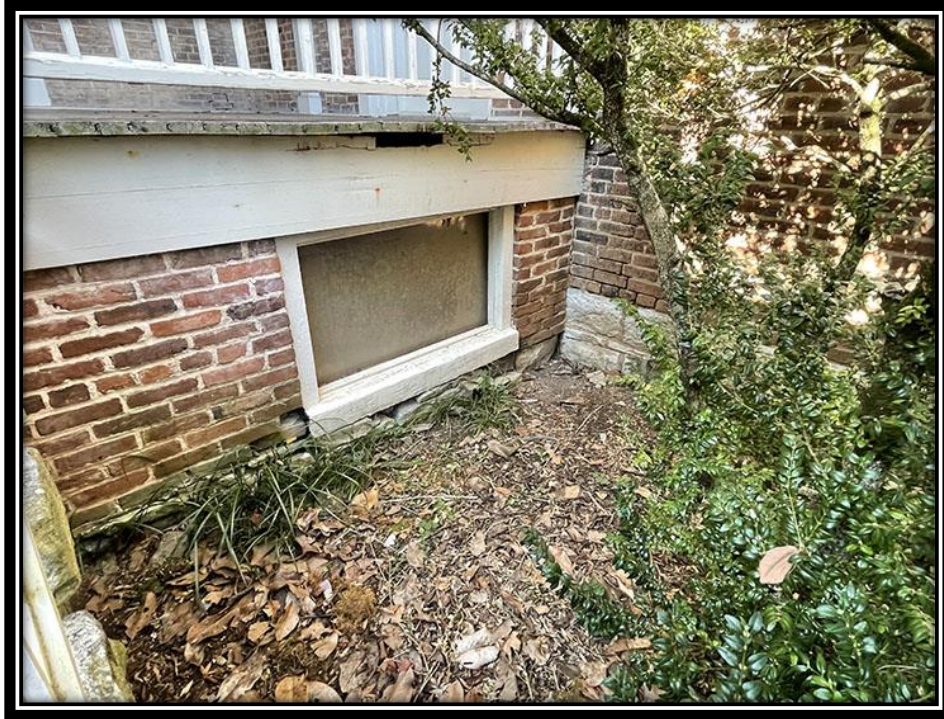
Deteriorated masonry wall and foundation and rotted skirt board. Porch floor joists also deteriorated over this window, December 2020.

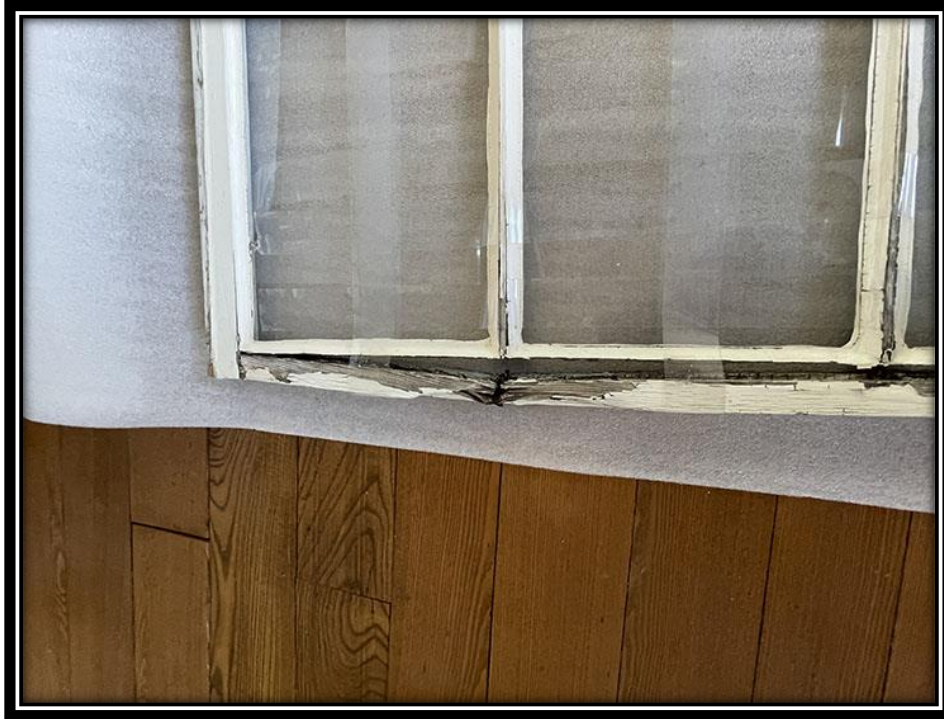
South wall south east second floor upper window sash removed due to a rotted bottom rail, November 2020. Many Tulip Grove windows are trending in this direction.

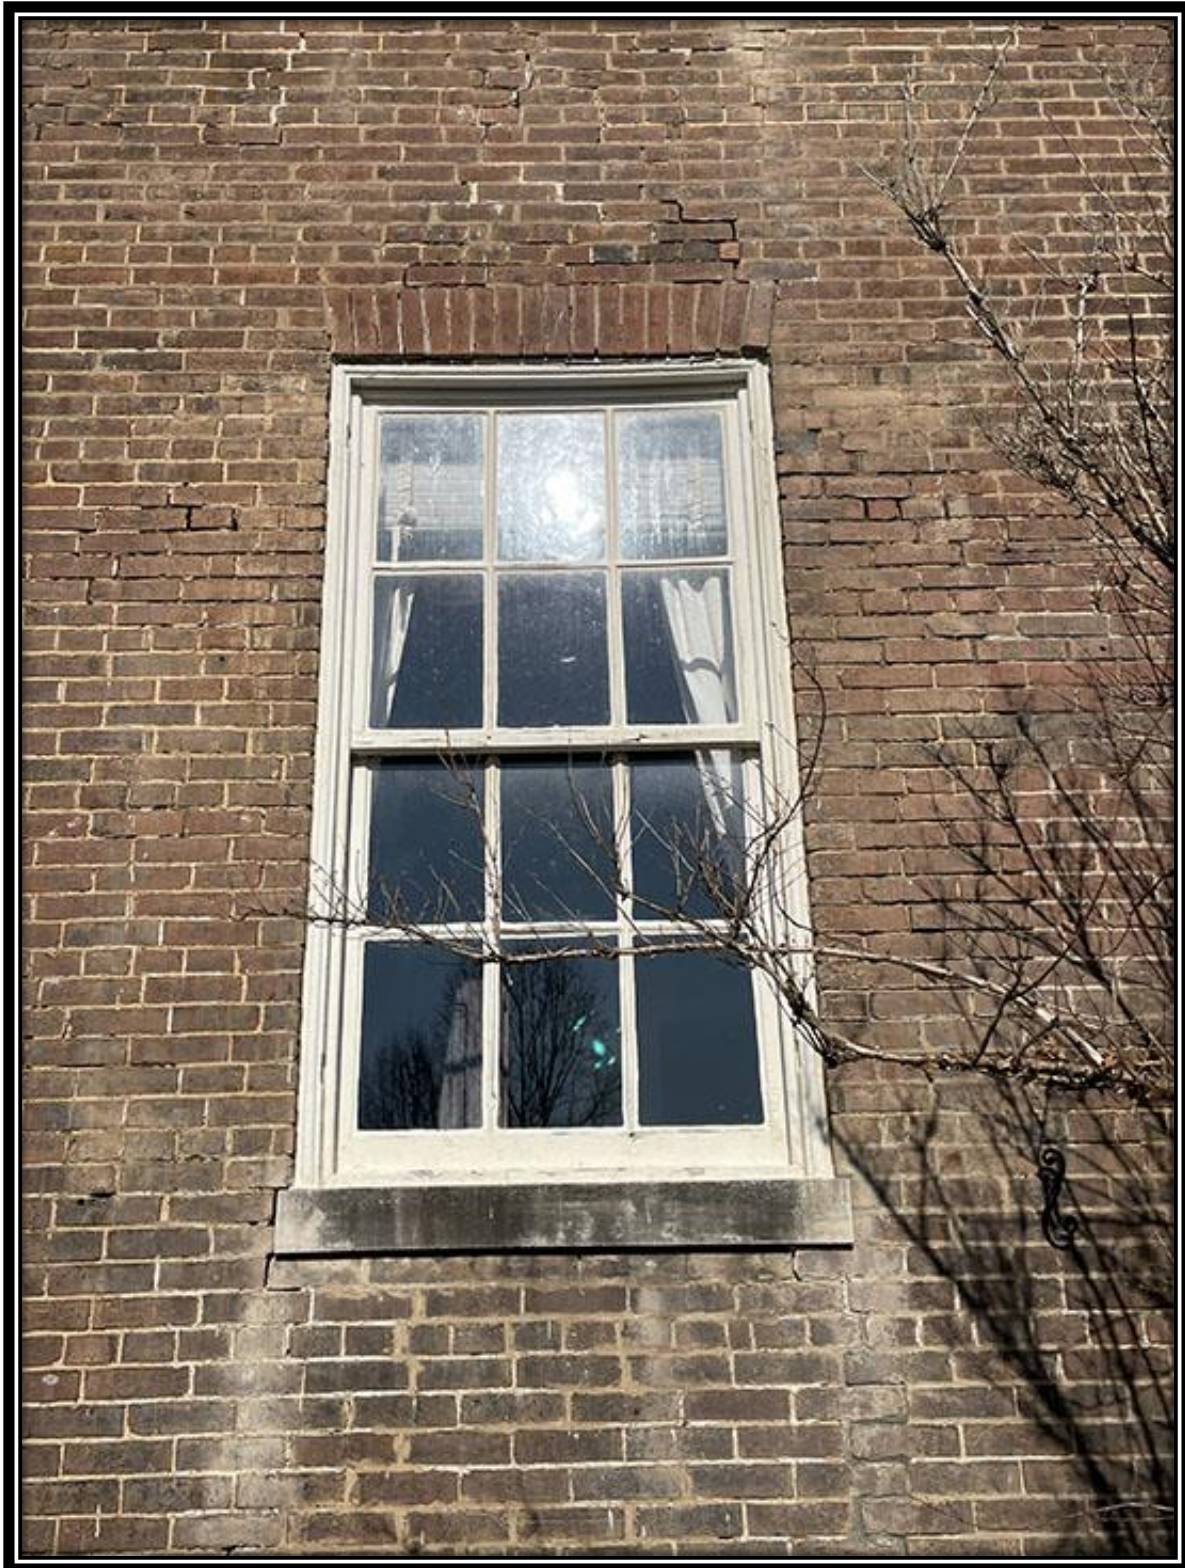
Typical Tulip Grove window and masonry wall condition. Note paint failure, step cracking, open mortar joints, and brick movement in jack arch.

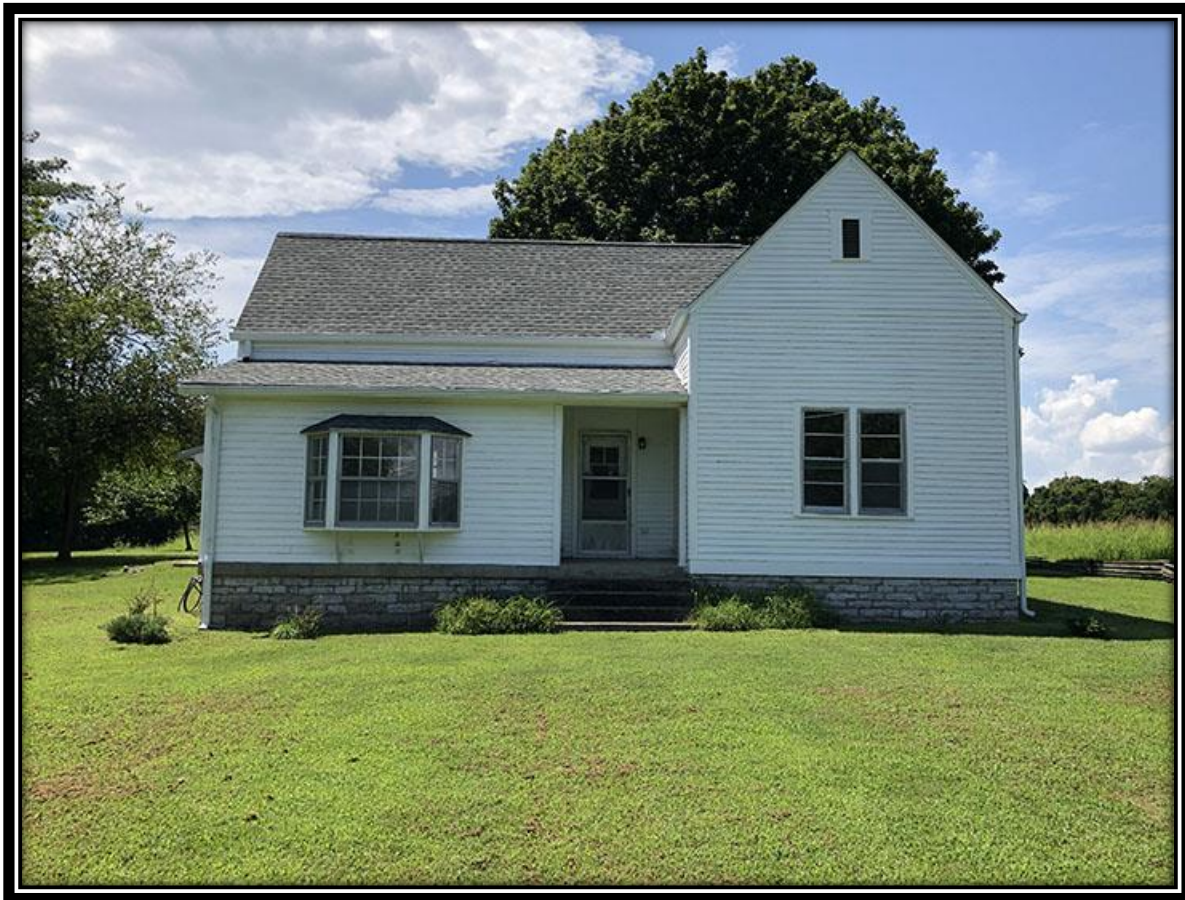
Hill's Lane House east elevation post-fire repair, July 2020.

In the 2019 Annual Report to the SBC, the AJF reported on a fire that extensively damaged a home that was known historically as the Tennessee Confederate Soldiers' Home Farm Manager's House. In the AJF era, this home has been called Hill's Lane House. Repair work began in July 2019 and finished in May 2020. Due to the severity of the fire in the attic, the entire roof structure, rafters, sheathing, shingles, and flashing had to be completely replaced. All ceilings in the home had to be removed due to water damage. Interior repairs included: replumb and remodel of the bathroom; installation of new electrical wiring; installation of a HVAC unit; all new dry wall ceilings, removal of asbestos from the home, new kitchen cabinetry, and complete repainting.

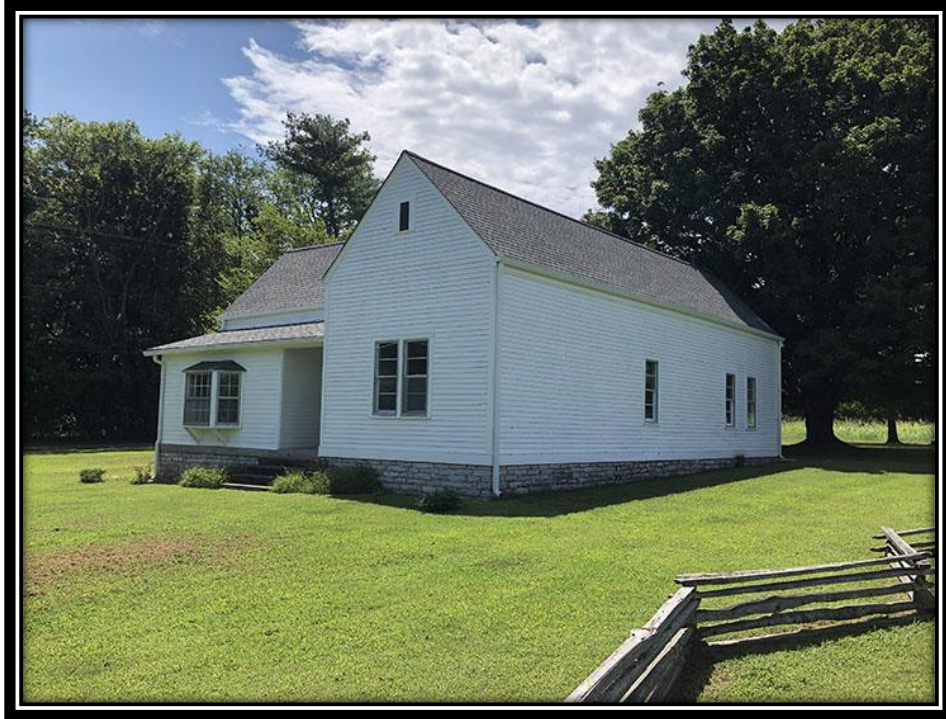
Hill's Lane House east and north elevations post-fire repair, July 2020.

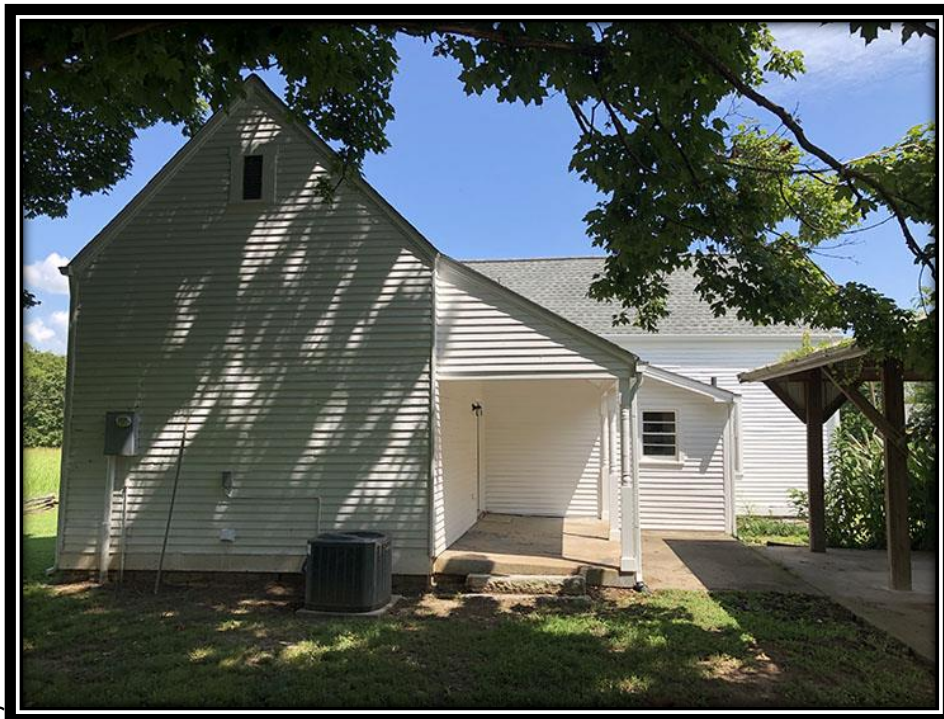
Hill's Lane House west elevation post-fire repair, July 2020.

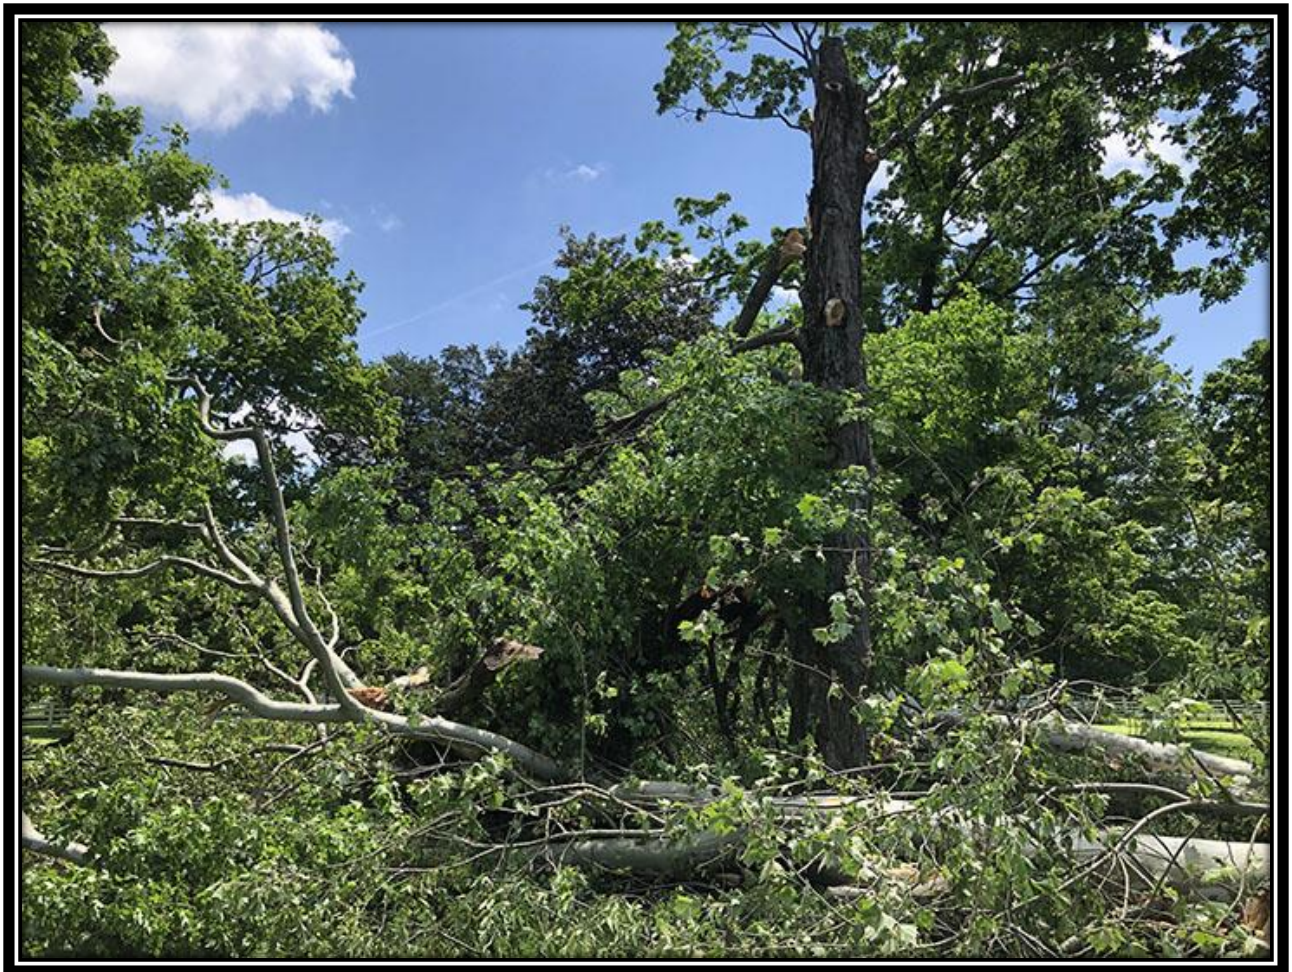
Six 100-year-old trees just a few hundred feet from the Hermitage mansion toppled during the May 3, 2020 Derecho.
